John R. Clark Farm
HO-880
5159 Beaverbrook Road, Columbia
Howard County
Ca. 1870-1940s
Private

Maryland Historical Trust Maryland Inventory of Historic Properties Form

JOHN R. CLARK FARM CA. 1870, REMODELED 1937

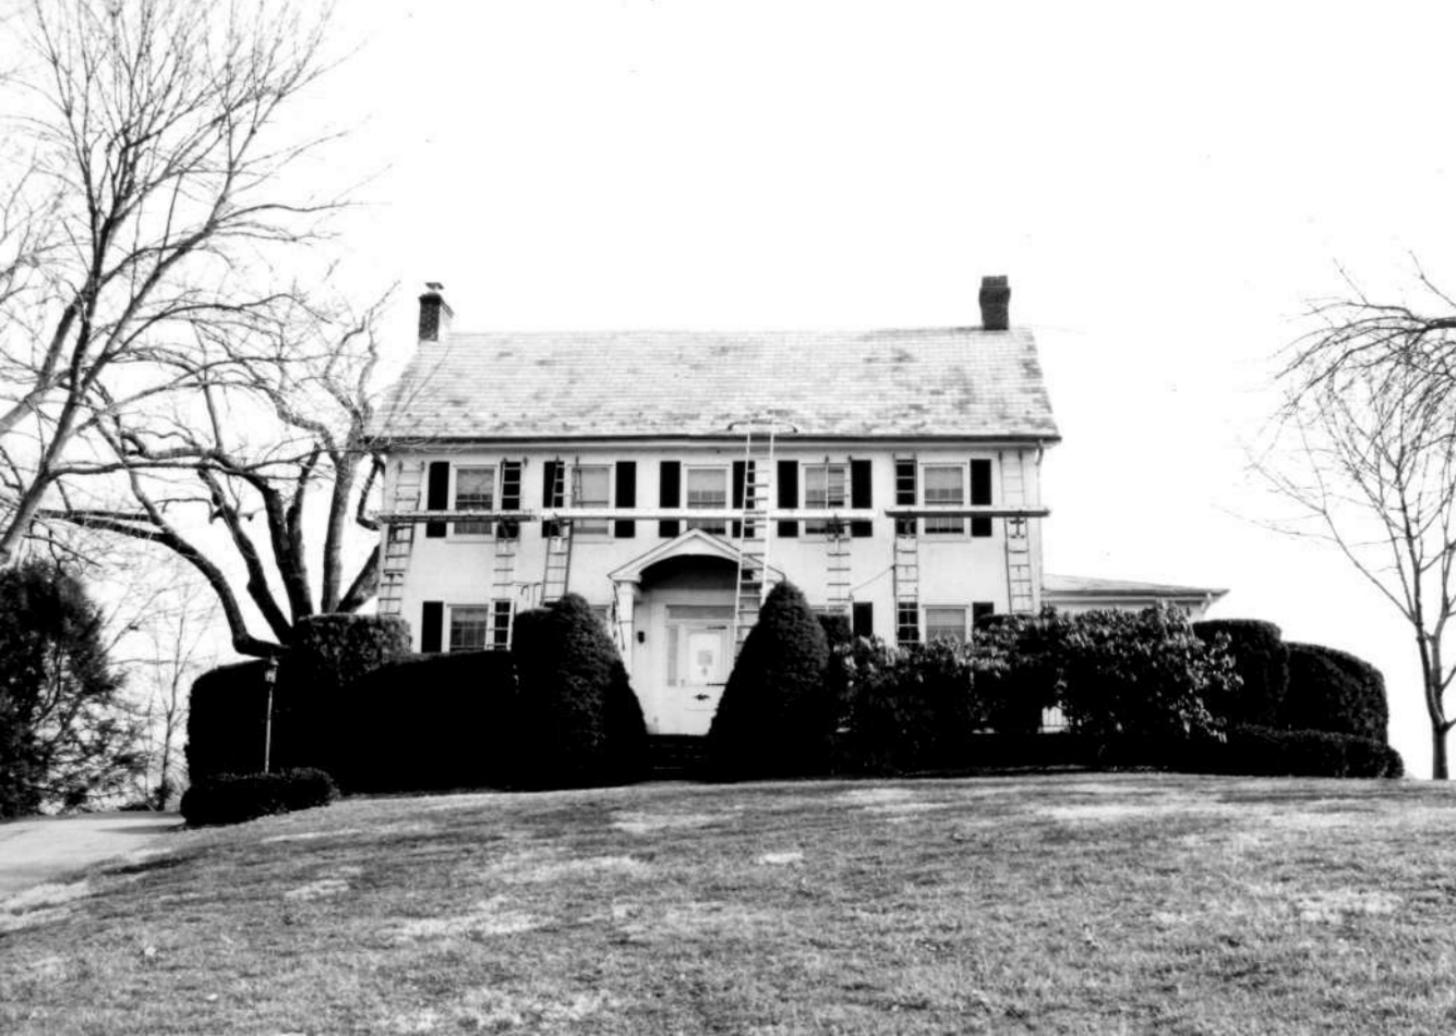
40617

Views . Shows main house primary facade.

The primary facade of the main house faces north. The 5-bay primary facade is symmetrical about its entry bay. Openings are vertically aligned and graduated. The centered entry door configuration consists of the front door opening with a two-light over one-panel sidelights and a three-light transom. The entry door opening holds a ca. 1937 wood door, is framed by wood pilasters and cornice and covered by a ca. 1937 entry door hood with a triangular pediment supported by flared square columns. A flagstone walk leads to the front door, and three stone steps provide the transition to a broad stone veranda that extends across the front of the house, all added in ca. 1937.

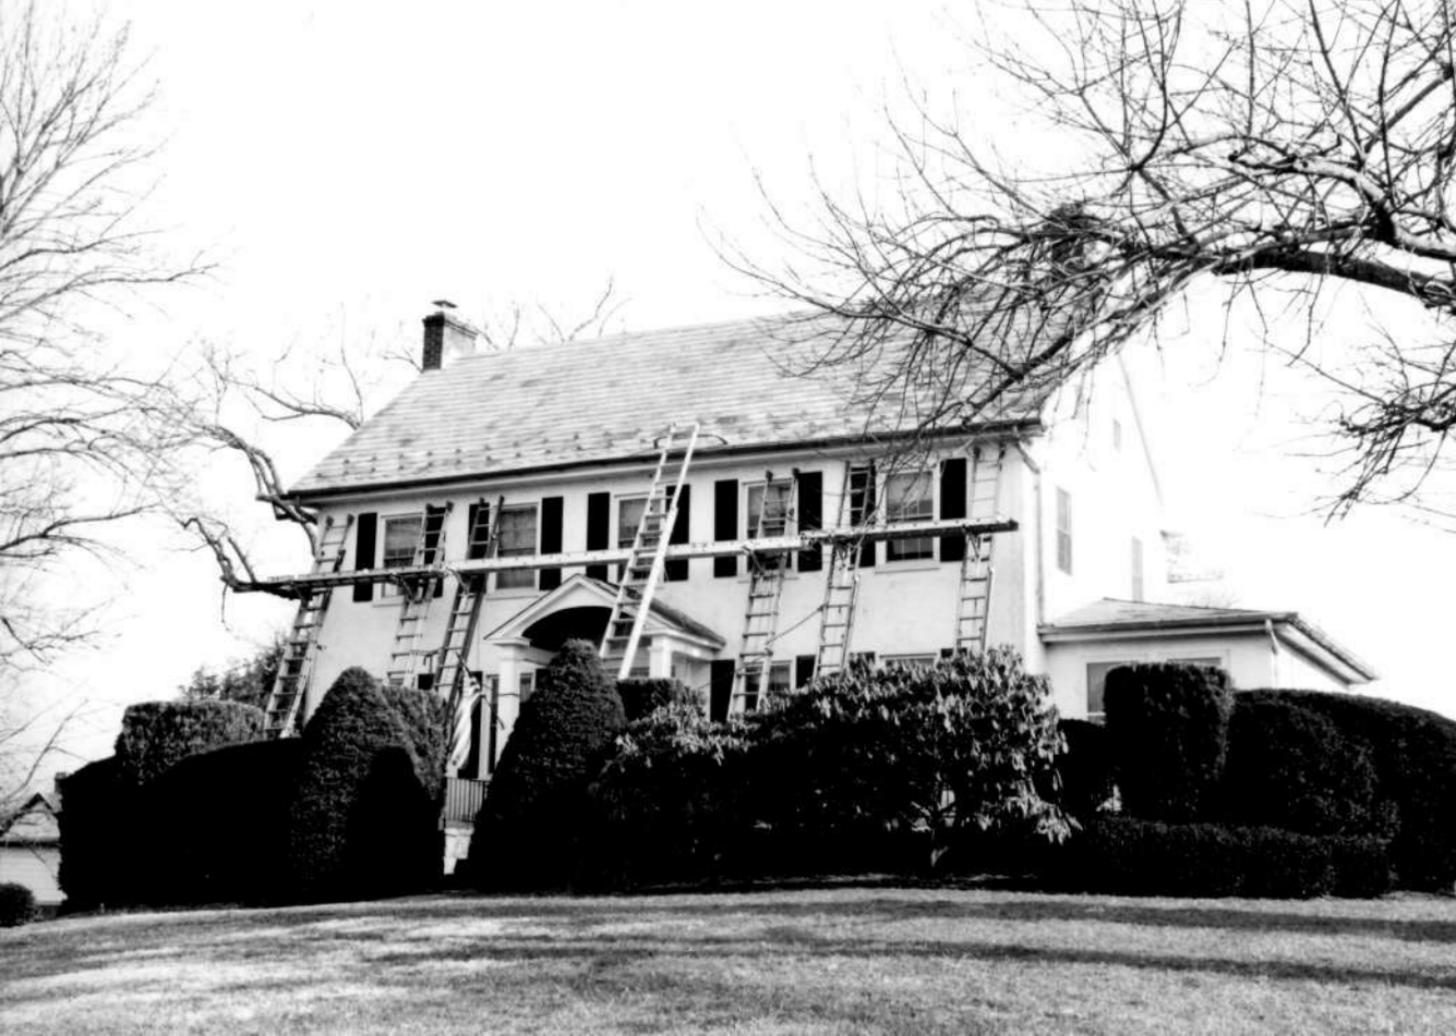
50617

View SE. Shows front + side facades of
main house.

The east (side) facade of the main house is two bays wide. A ca. 1937 stone and brick exterior fireplace chimney is centered on the gable end. Window openings on the 1st and 2nd stories are vertically aligned and graduated. Small attic story window openings flank the chimney. One cellar story window opening, which is vertically aligned with the 1st and 2nd story openings, is located north of the chimney. A metal cellar bulkhead entry is located south of the chimney.

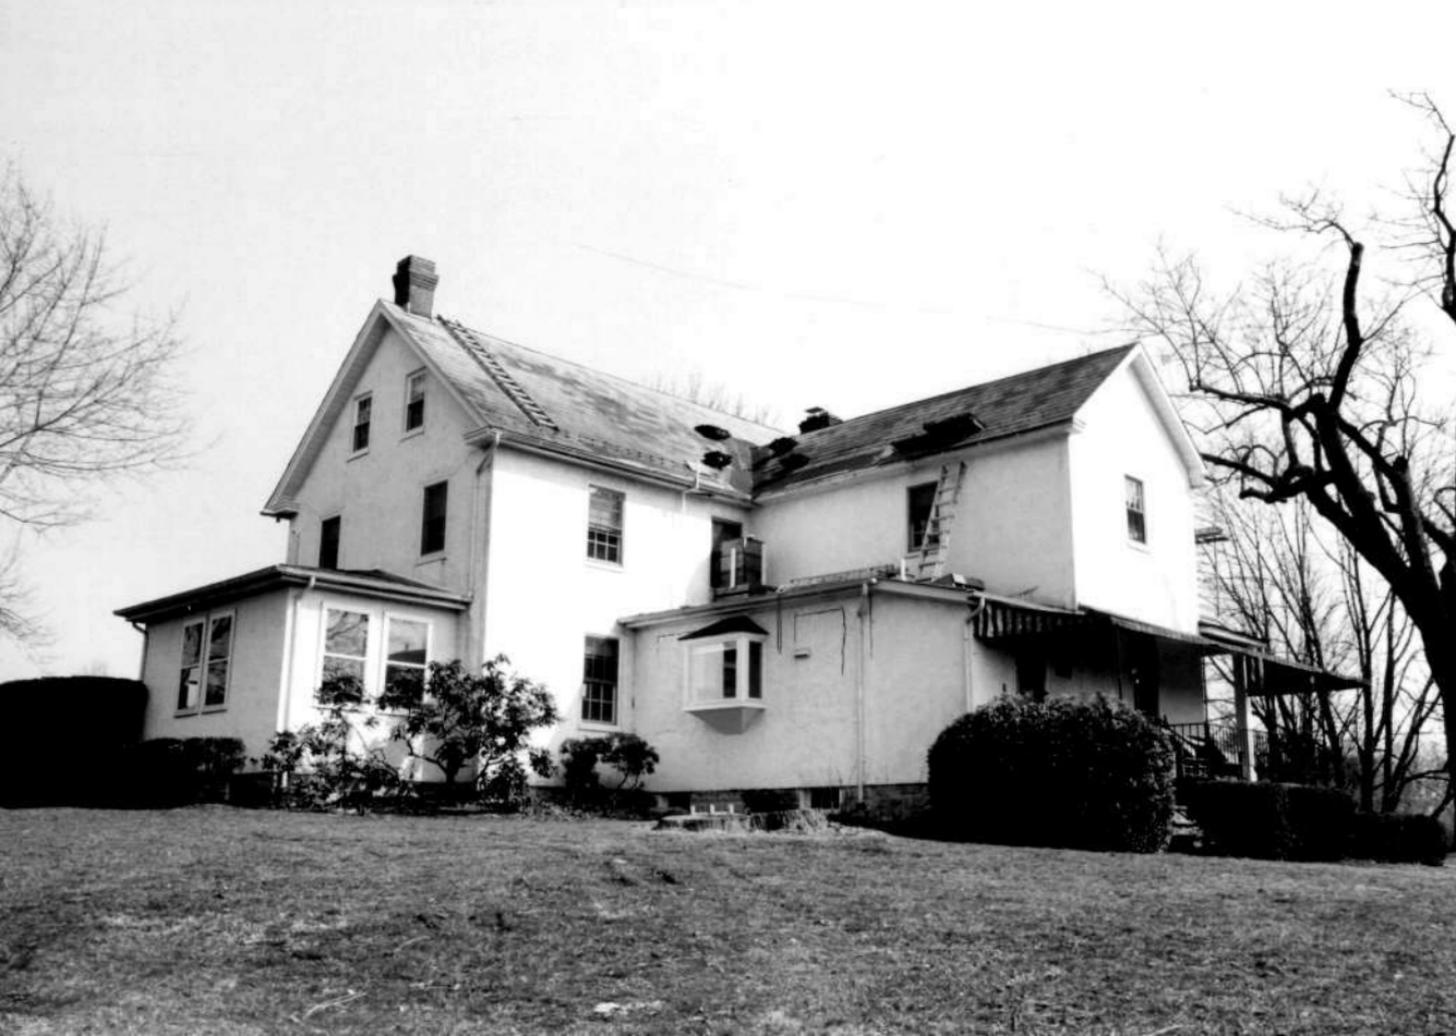
606 17

View NE. Shows side + rear facades of ca.
1800's, 1840's sections of house.

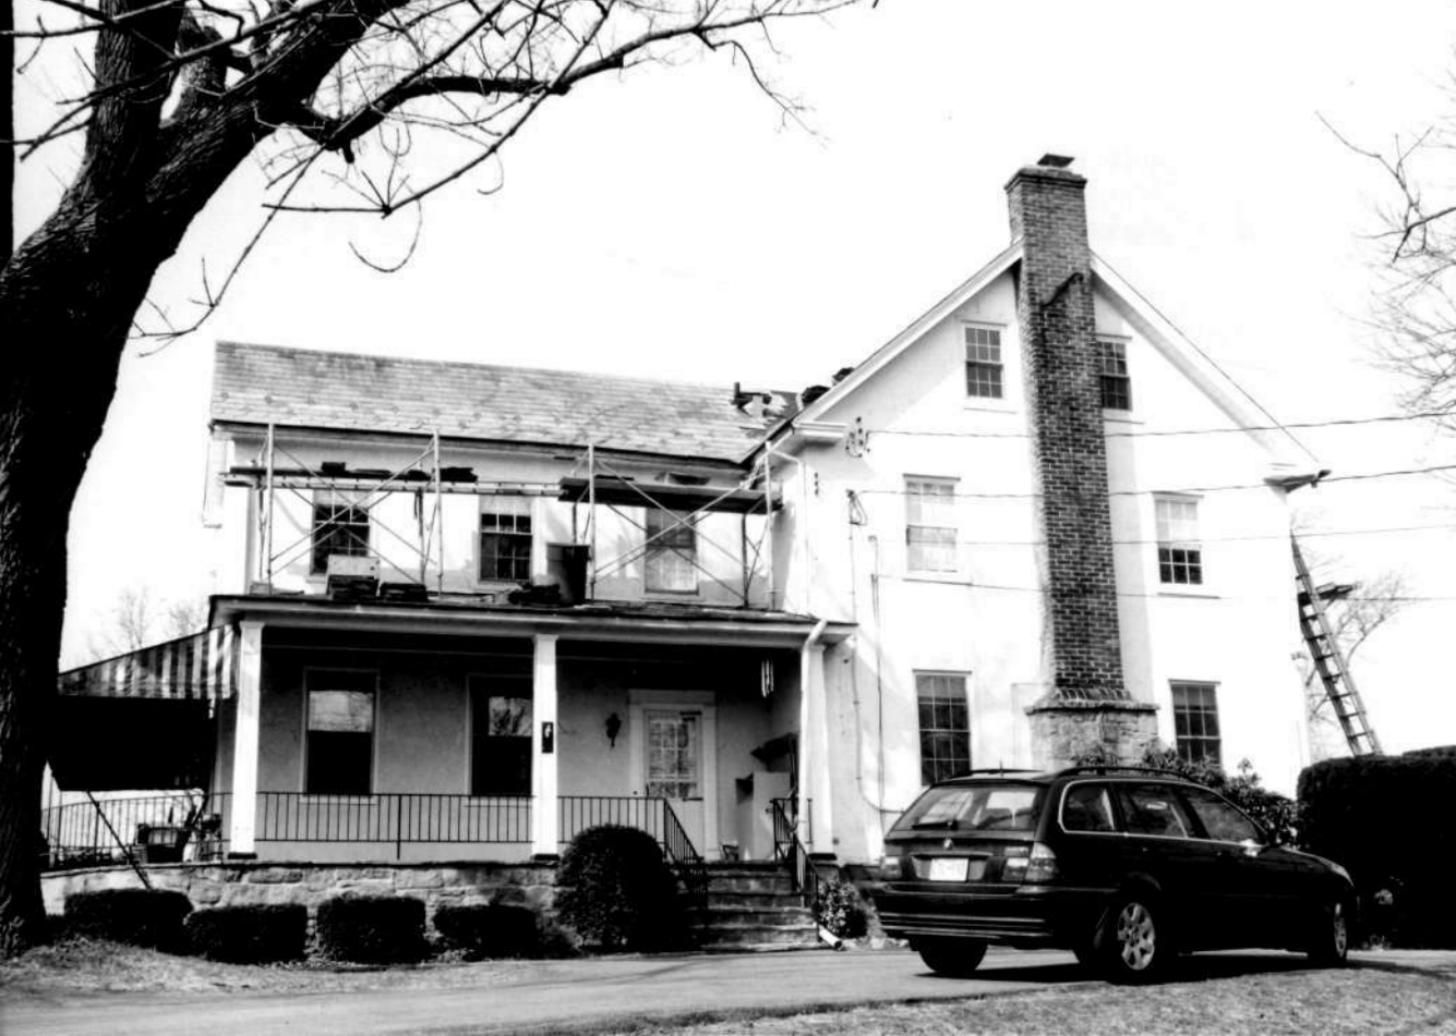
7.6.17

View W. Shows side facades of ca. 1800's +
ca 1840s sections of house.

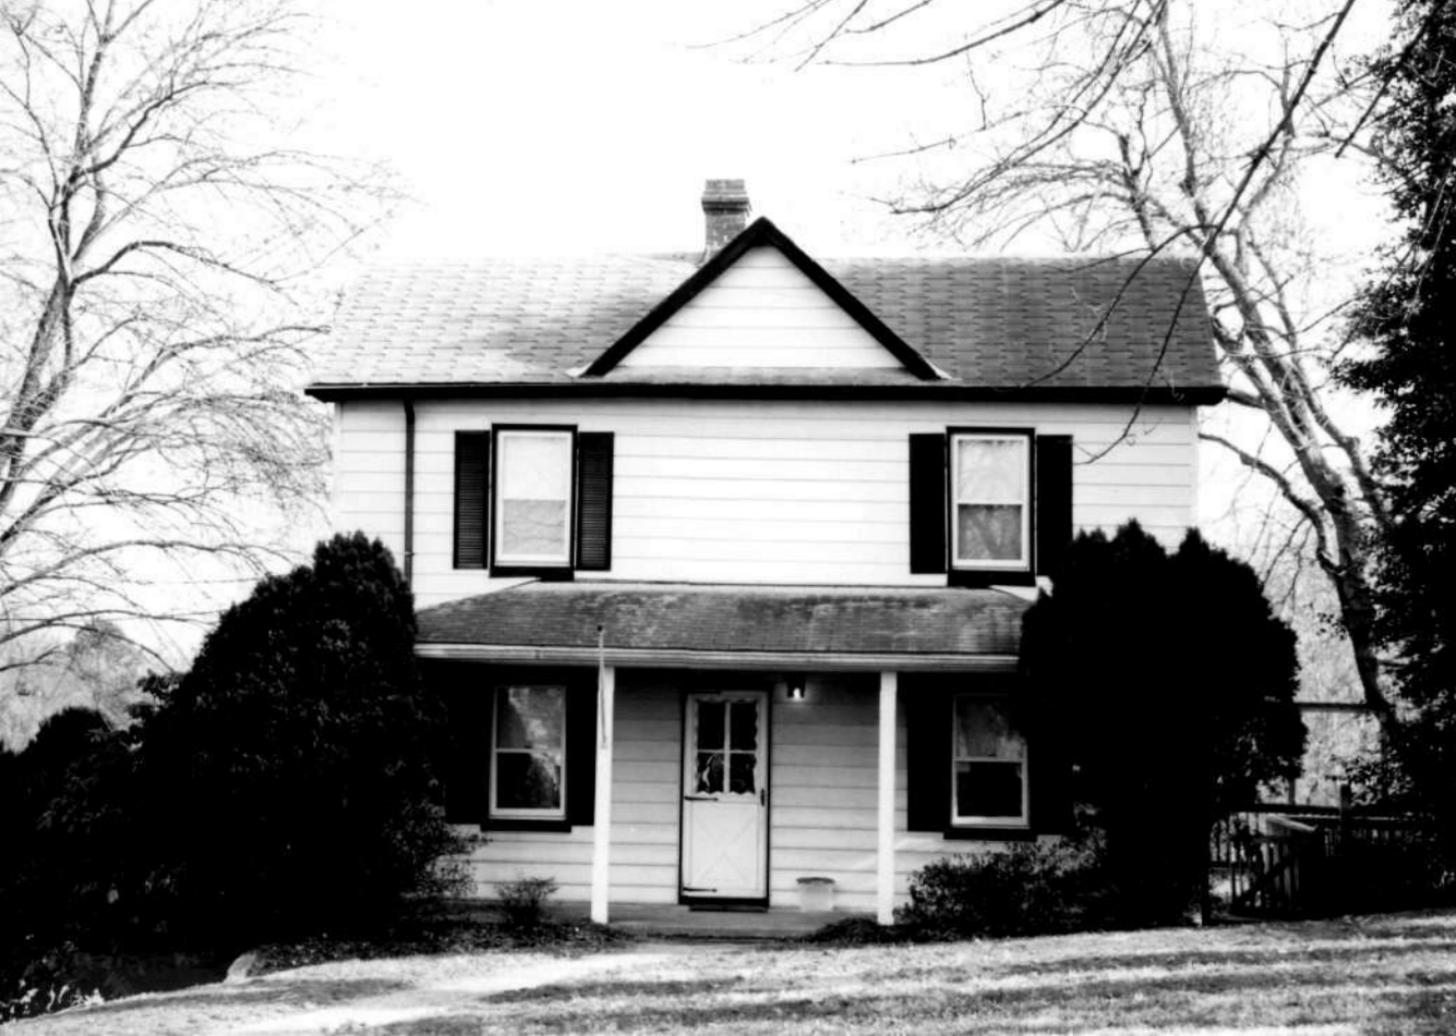
8 of 17

View S. Shows tenant house, front facade.

The primary facade of the tenant house faces north. The 1st story has a door opening flanked by window openings. The door opening, which holds an early 20th c. wood four-light over two-panel door, is located west of center because of the two-room interior plan. The 2nd story has two window openings that are vertically aligned with the 1st story window openings. The attic gable has one opening, now covered with siding, that is visible from the interior of the attic. A one-story, hipped-roof porch extends across the front facade. The porch has square wood posts and a concrete deck that is almost flush with the ground.

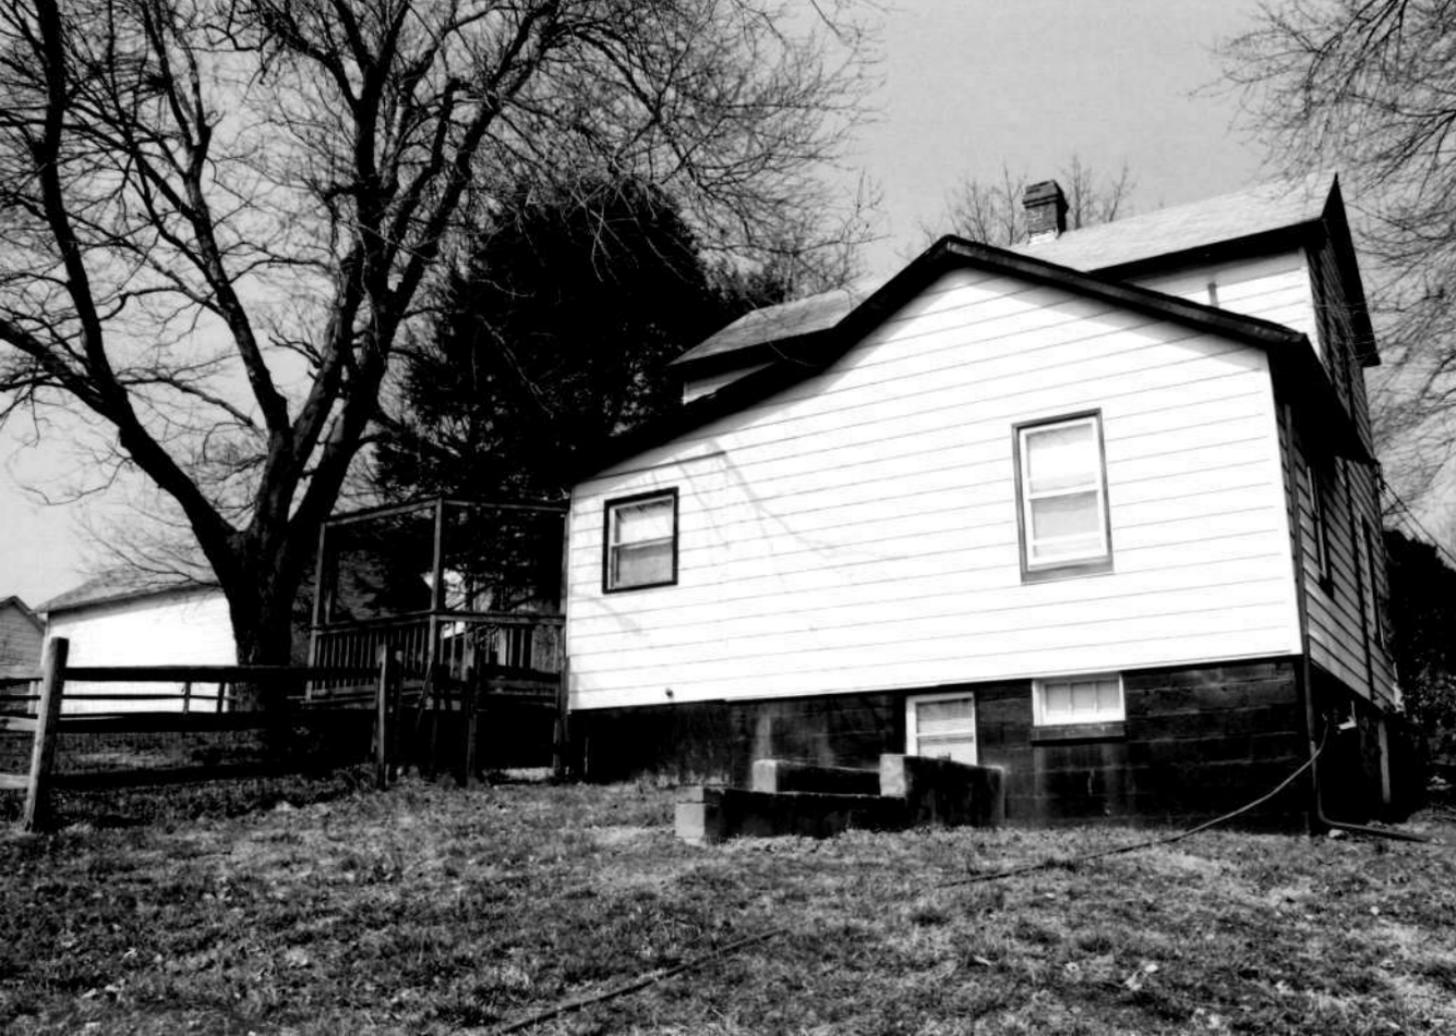
906 17

View N. Shows tenant house, rear facade.

The south (rear) facade of the house is composed of the rear facade of the main house and the south facade of the one-story addition. Because the one-story addition extends across the rear facade of the main house, only the 2nd story of the main house is visible. The 2nd story of the main house has one window opening, located in the western bay. The gable end of the 1-story rear addition has a compound roof form because the addition originally included an open porch (now enclosed) that faced west. The rear facade of the addition has two 1st-story window openings: one is located east of the gable and one is located in the enclosed section of the porch. The cellar story has two openings: one is a window opening that is vertically aligned with the 1st story window opening east of the

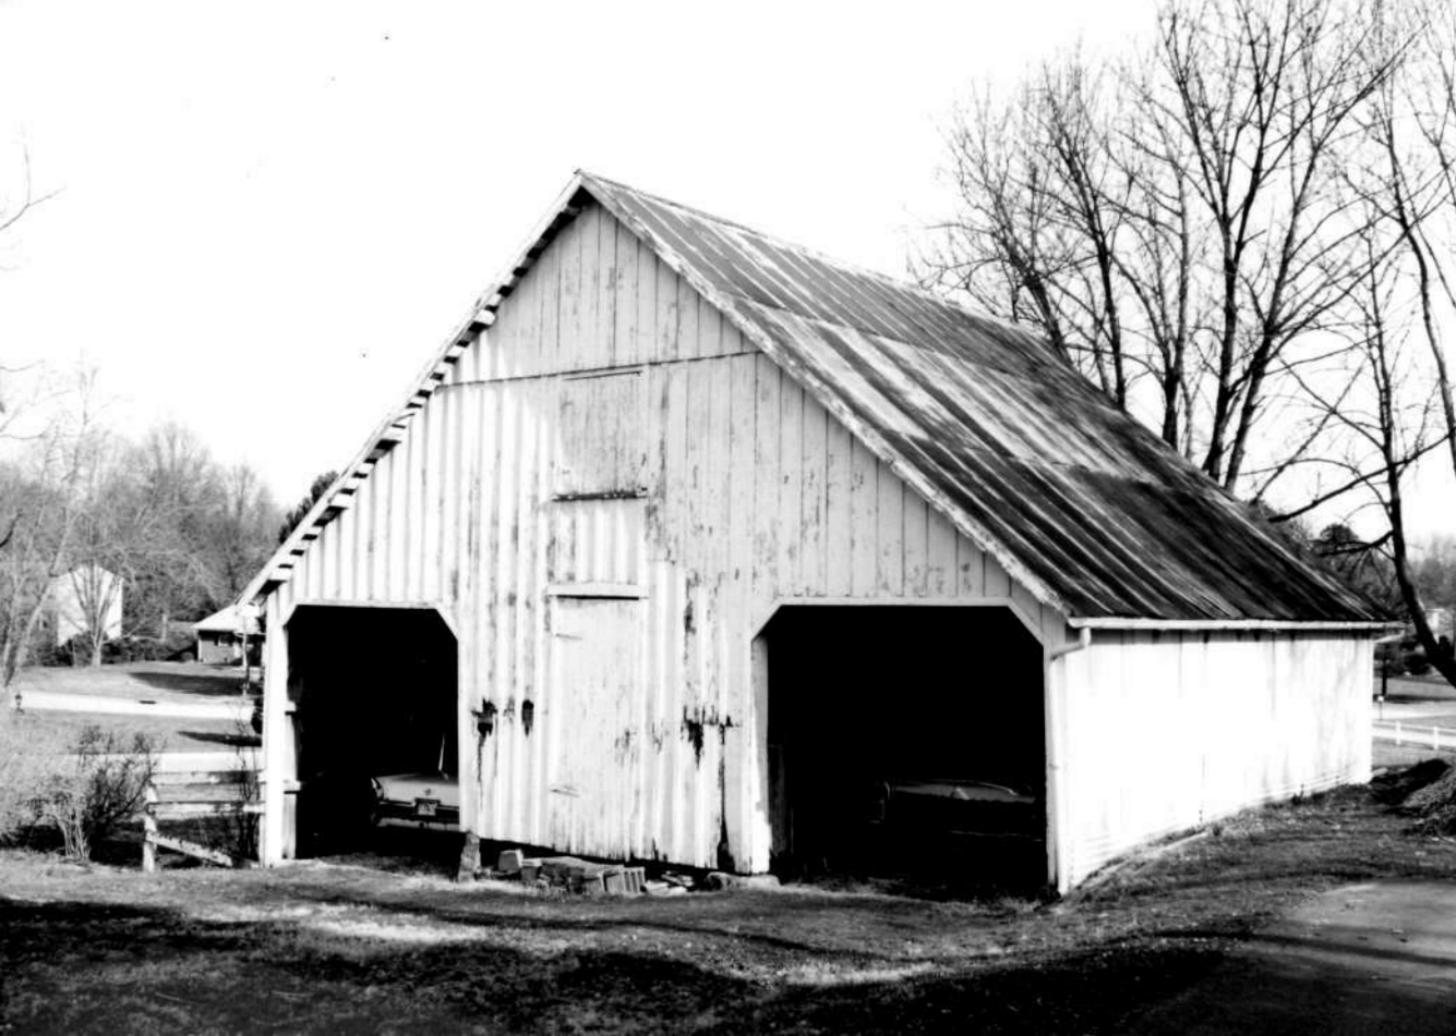
10 06 17

view SE. Shows wagon shed, front + side
facades.

The primary facade of the wagon shed faces north. The north facade is sheathed in board and batten siding. On the north facade, the centered entry door opening is flanked by a pair of vehicular openings. The entry opening, with pediment, holds a wood beadboard door. A loft door is centered in the gable.

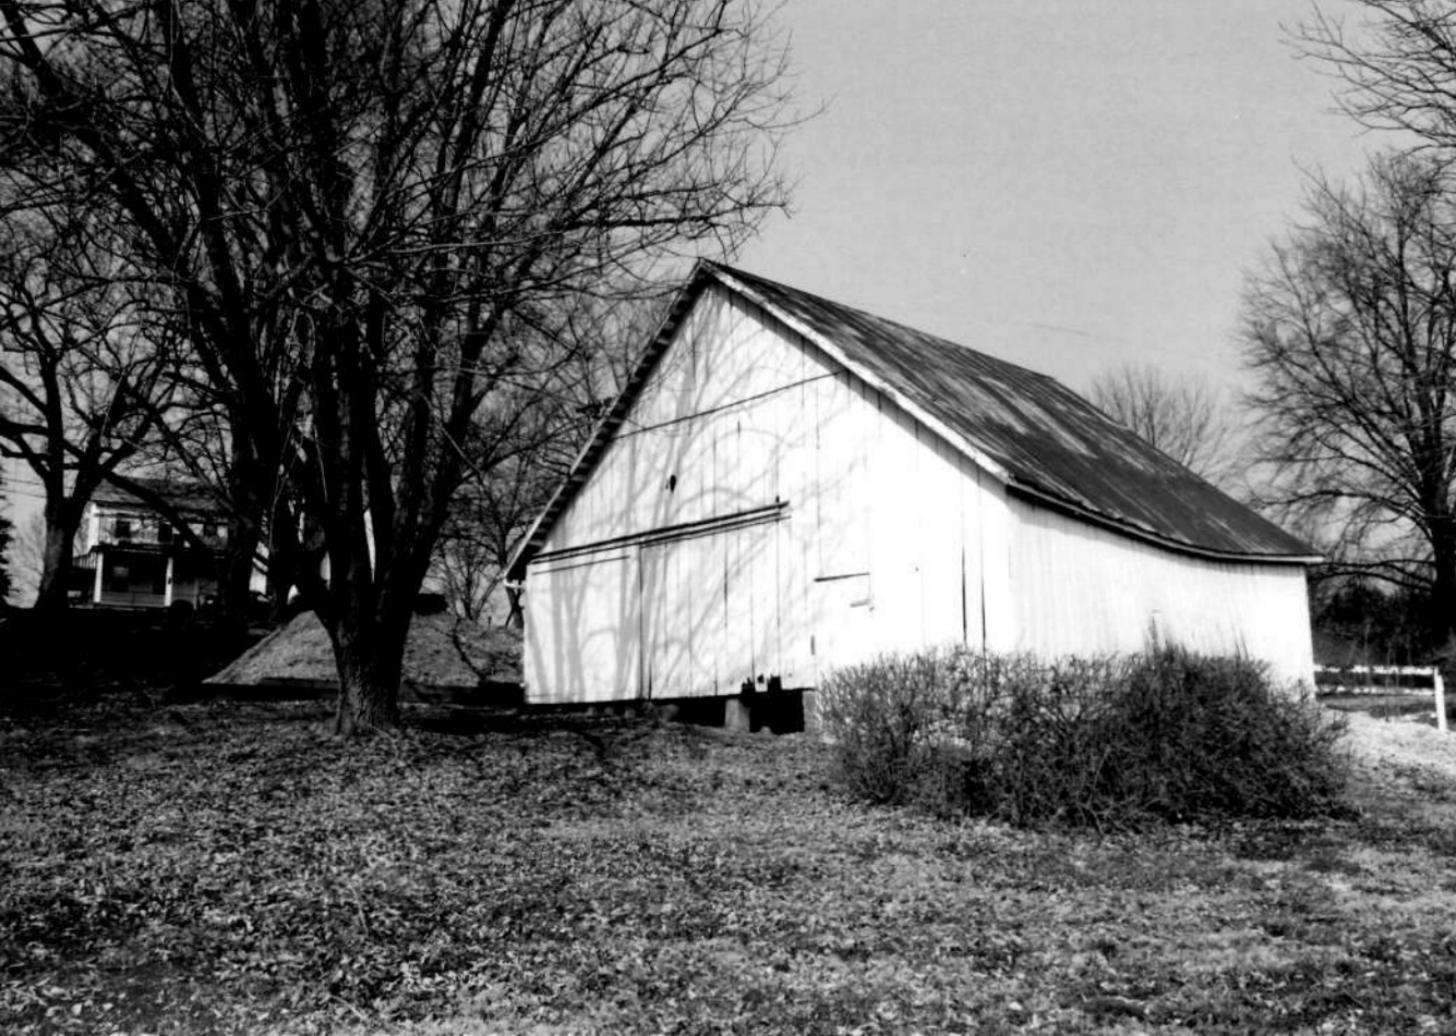
11 06 17

View NW. Shows wagon shed, rear + side
facades

The south facade is sheathed in vertical wood siding and has two door openings. The western opening is a vehicular opening with a sliding wood beadboard door. The eastern opening is an entry door opening with a wood door.

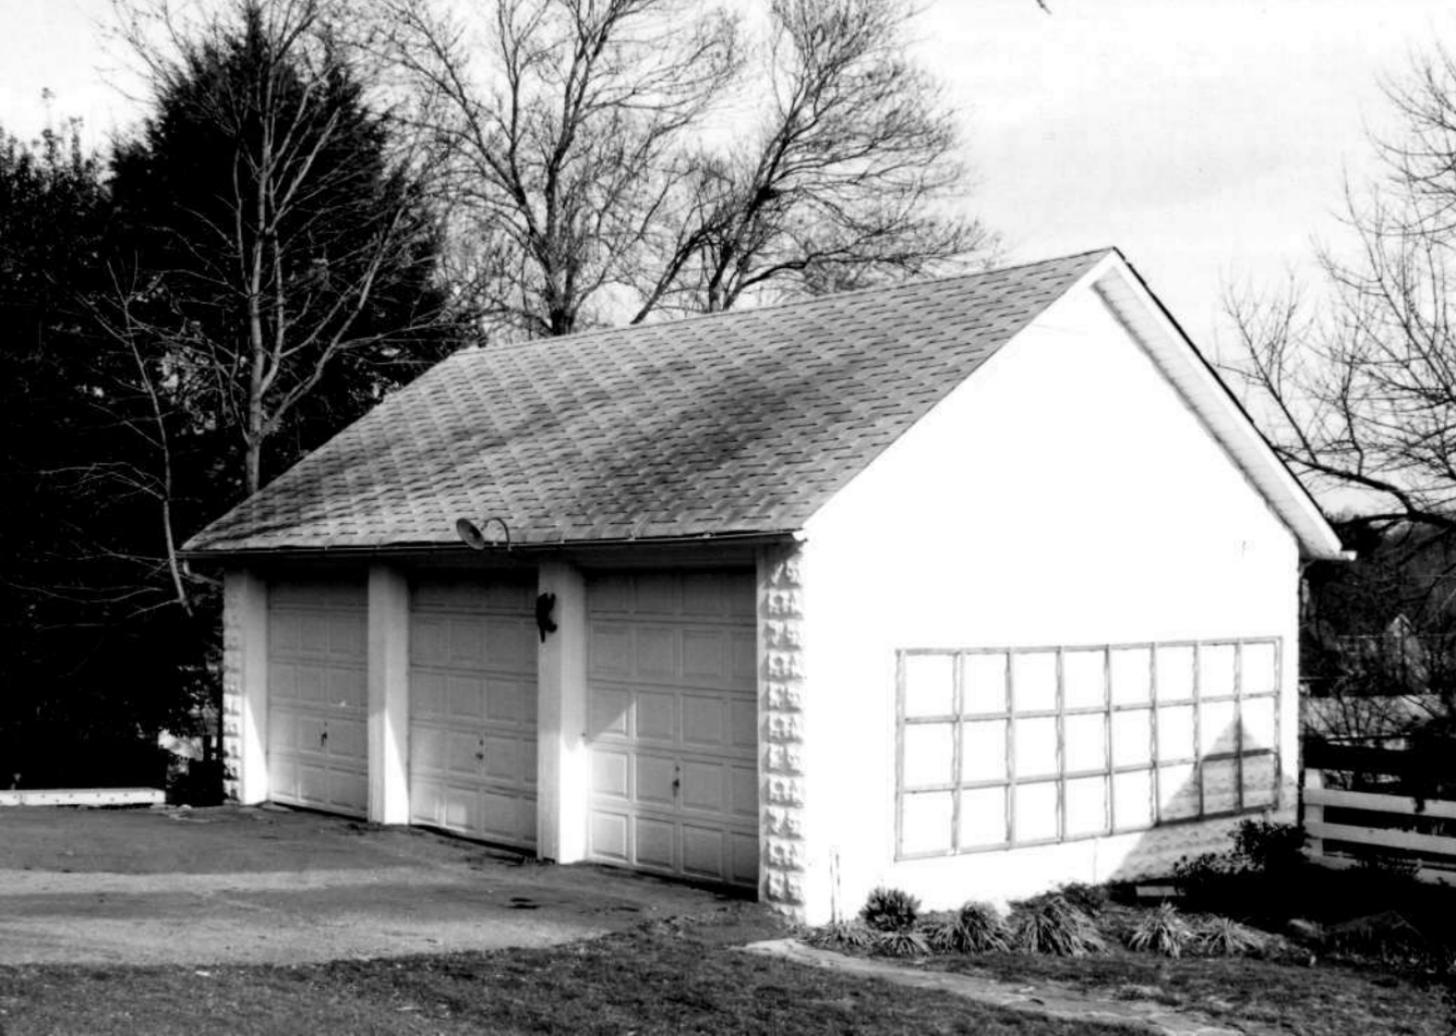
1206 17

View SE shows garage, front + side
facades.

The ca. 1937, 1-story, side-gable garage is located south of the main house. The garage is constructed of rusticated CMU and has an asphalt roof. The primary facade of the smokehouse faces north and is three bays wide. Three vehicular openings, which hold recent paneled garage doors, span the front facade. The east, west, and south facades do not have any openings.

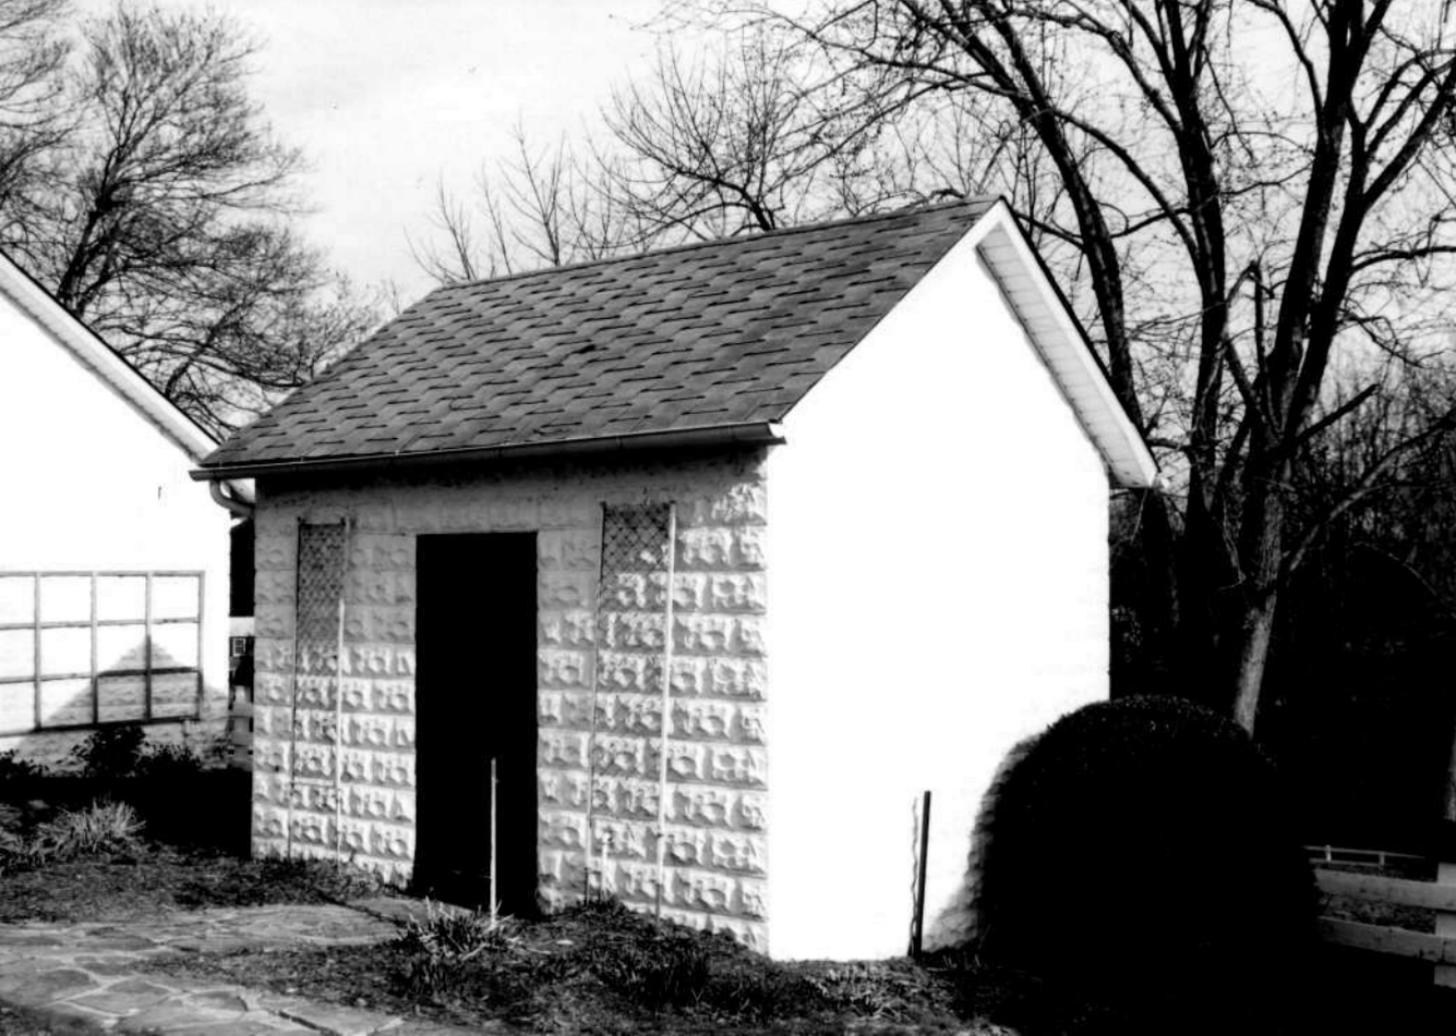
130617

View SE. Snows Smoke house.

The ca. 1937, 1-story, side-gable smokehouse is located south of the main house. The smoke house is constructed of rusticated CMU and has an asphalt roof. The primary facade of the smokehouse faces north. The door opening is centered in the north facade and holds a heavy wood door with diagonal board panels. The interior of the smokehouse is a single cell space. The wood framed roof displays the characteristic black discoloration from smoking meats. The east, west, and south facades do not have any openings.

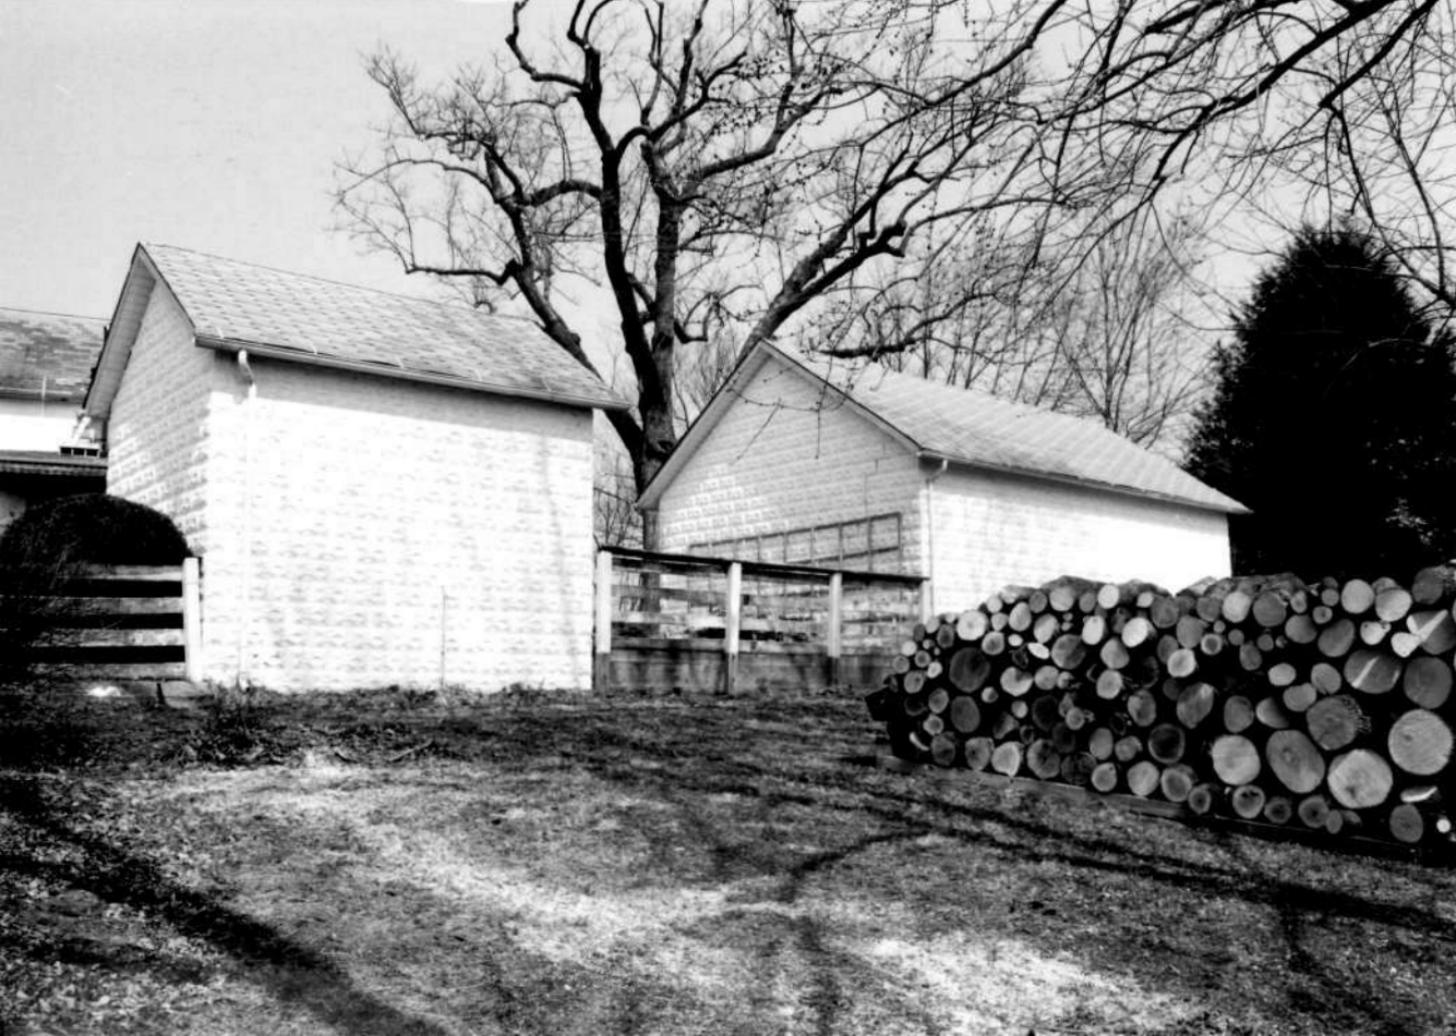
140617

View NE Shows smokehouse and garage,
side and rear facades.

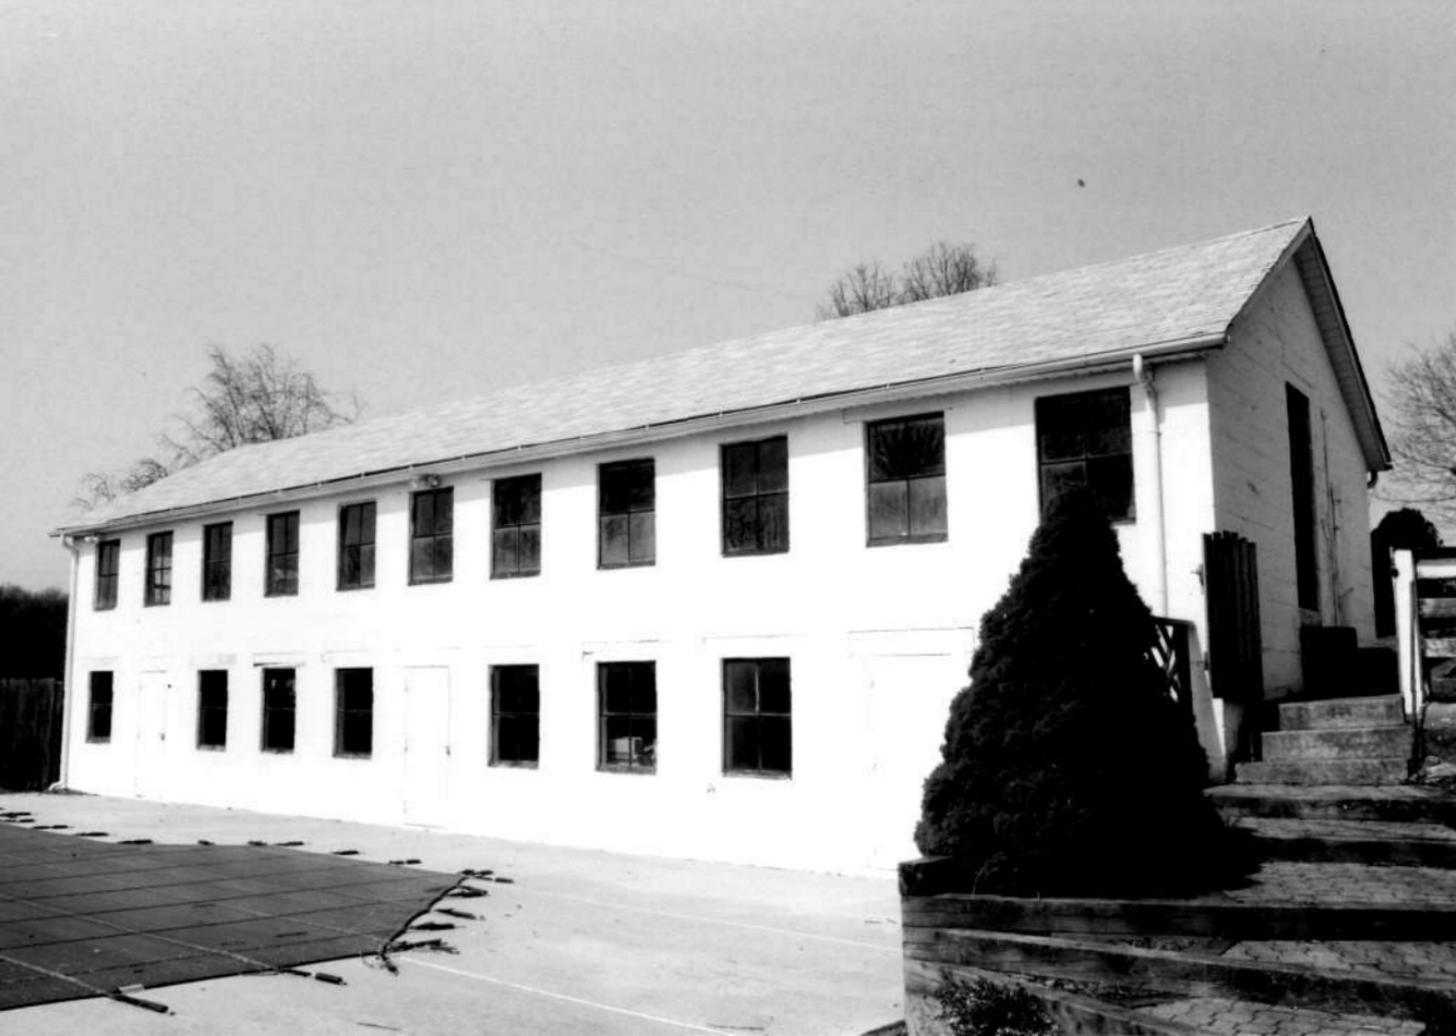
1506 17

View N. Shows primary + side facades
of workshop.

The primary facade of the building faces south and is 15 bays wide. The 1st and 2nd story openings are vertically aligned. From east to west the first story pattern of window and door openings is w, d, w, w, w, d, w, w, w, d, w, w, w, d, w. All fifteen 2nd-story openings are windows. The east (side) facade has one centered door opening that access the 2nd story. The west (side) facade is two bays wide. The 1st and 2nd story window openings are vertically aligned. The north (rear) facade, which faces the house, does not have any openings.

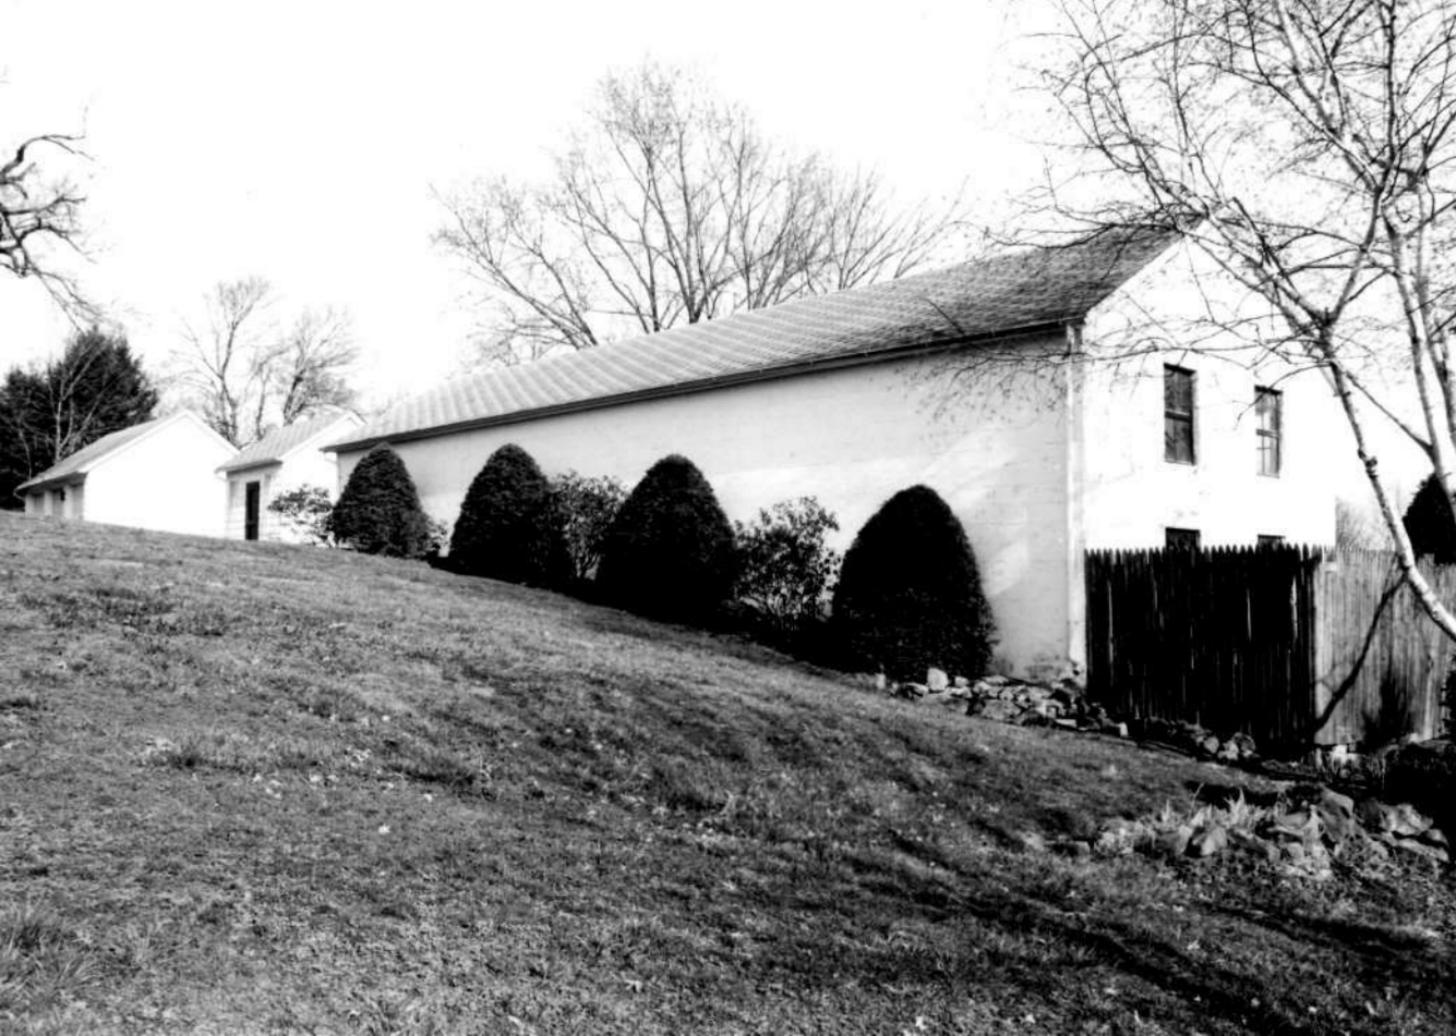
1606 17

VIEW SE. Shows rear + side facades of

Workshop.

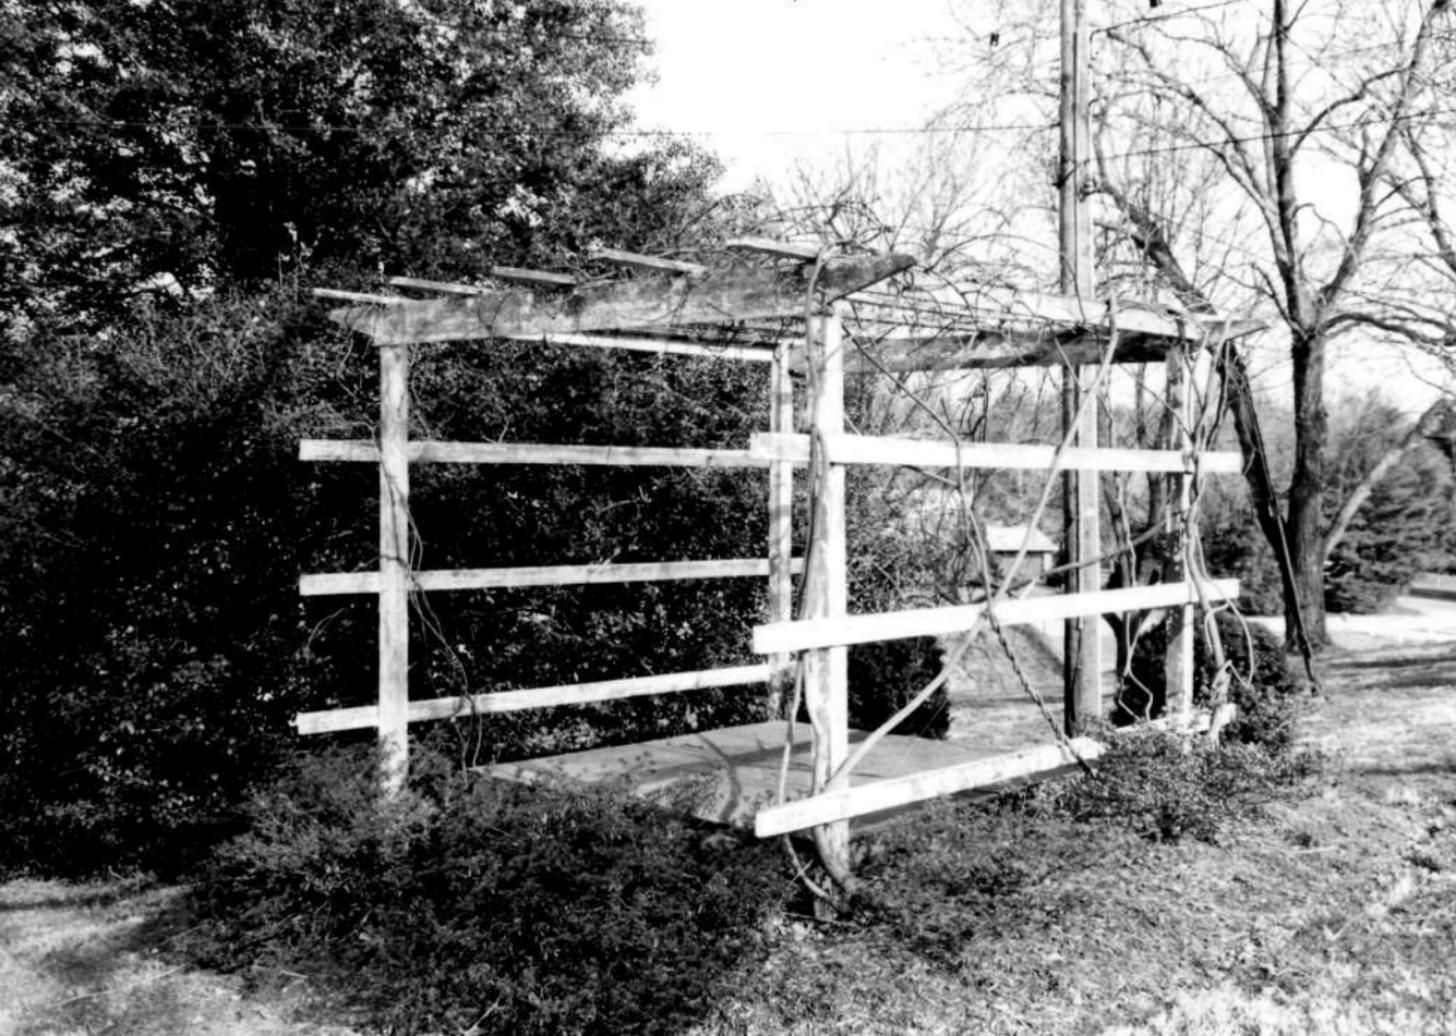
170617

View N. Shows well.
